Dear Garmin-Support,

I discovered a problem with the NMEA \$GPWPL sentences on the GPSmap 60CS. (Until May this year I had a GPSmap 60, and there this problem did not occur, so I assume that this must be a bug.)

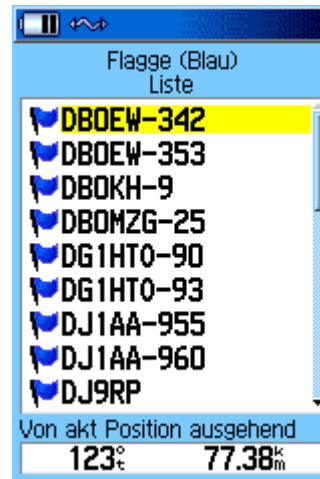
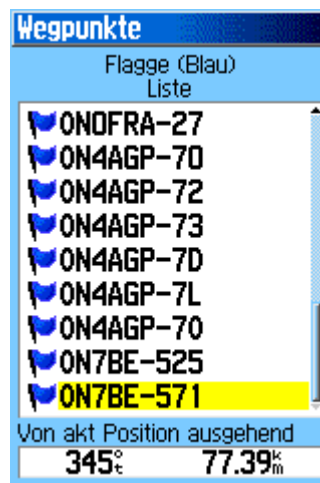
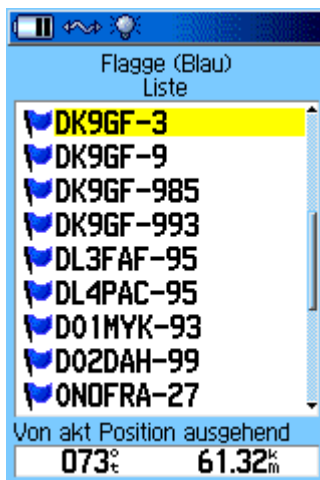
The Waypoint name is i.e. DL4PAC-9 (the SSID „-9“ means that this waypoint is a moving car, -4 means a bike, -8 a boat, -7 a bus, -2 a fixed Repeater, and so on)

\$GPWPL creates a new Waypoint, sometimes with a new number or letter behind the same name, sometimes it updates the position of an already existing waypoint. The numbers behind sometimes seem to be a following number 1, 2, 3, etc. Sometimes the number behind isn't in any relation with the NMEA-input...

From my experience with the GPSmap 60 (the green one) I expect that a new \$GPWPL-Sentences containing the same name, but different coordinates overwrites the old coordinates of the waypoint having this name. As I use it for Realtimetracking the reaction of the GPSmap 60CS is really strange for me, as pointing with the Compass on DL4PAC-9 makes no sense if new position data is saved under DL4PAC-9F.

If it would create a name i.e. LX1SB-9 1, LX1SB-9 2, LX1SB-9 3, LX1SB-9 4, LX1SB-9 5,.... , LX1SB-9 45,.... , LX1SB-9 67, I could understand this behaviour, even if it is not very useful, as it forces me to erase the waypoints every day in order not reach the limit of the waypoint memory, but this behaviour, creating waypoints like these e.g.

LX1SB-93E
or , LX1SB-960

looks like a bug for me.

Could you please have a look on it and include a fix in the next Unit-Software-Update? Thank you very much for your attention,
